NARRATIVE END ITEM REPORT

SATURN S-IVB-210

NARRATIVE END ITEM REPORT SATURN S-IVB-210

DOUGLAS REPORT DAC-56503

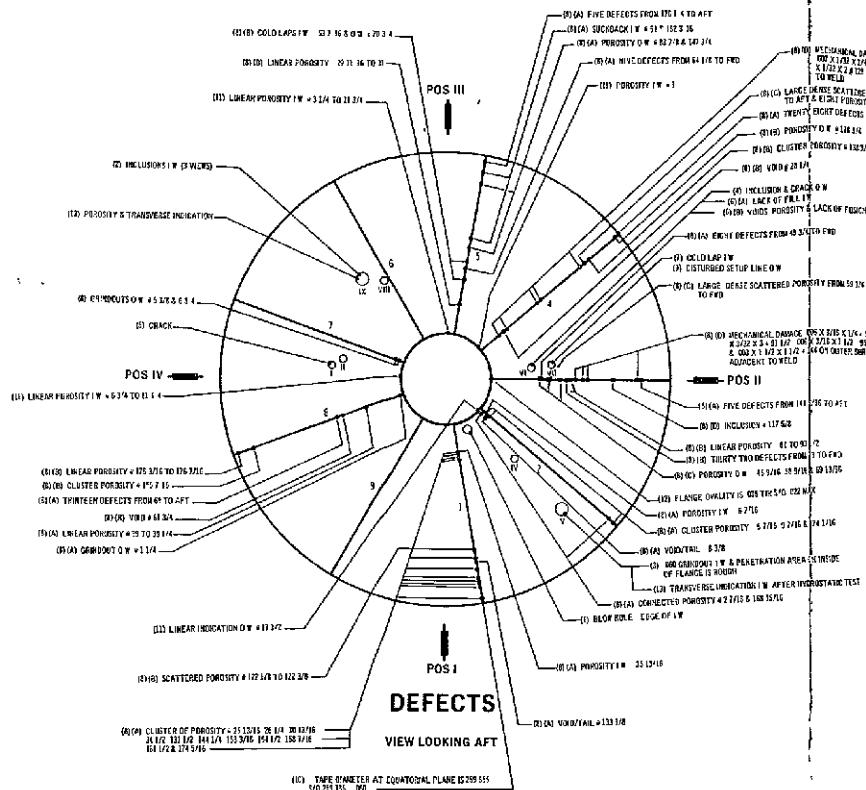
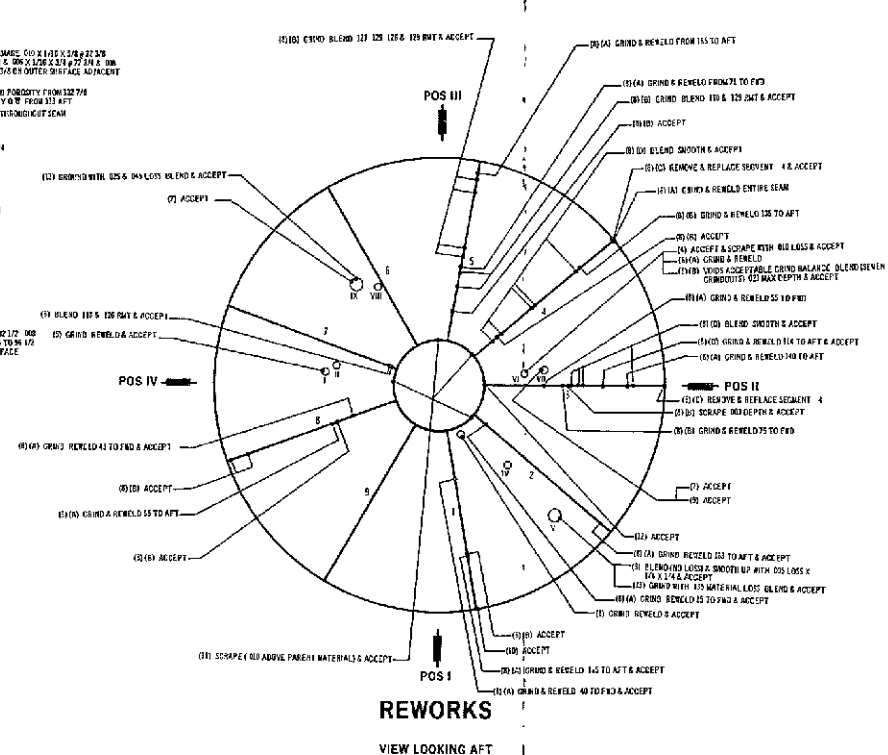
ITEM	FABR NUMBER	INITIATION DATE	DEFECTS	REWORKS REQUIRED	HOW REMOVED	REWORKS
(1)	A27046 EC	9-4-66	1	1	AUTO LIG	2
(2)	A27053 EE	9-7-66	1	1	B/A	0
(3)	A27073 FF	9-7-66	2	2	B/A	0
(4)	A27047 GG	9-25-66	2	1	B/A	0
(5)	A27048 HH	9-25-66	1	1	AUTO TIG	1
(6)	A27049 II	9-25-66	1	1	AUTO TIG	1
(7)	A27050 JJ	9-25-66	1	1	B/A	0
(8)	A27051 KK	9-25-66	1	1	AUTO TIG	1

ITEM	FABR NUMBER	INITIATION DATE	DEFECTS	REWORKS REQUIRED	WELDING REWORK	REWORKS
(9)	A27052 LL	10-15-66	1	1	B/A	0
(10)	A27053 EE	10-15-66	1	1	B/A	0
(11)	A27054 FF	10-15-66	1	1	B/A	0
(12)	A27055 GG	10-15-66	1	1	B/A	0
(13)	A27056 HH	10-15-66	1	1	B/A	0

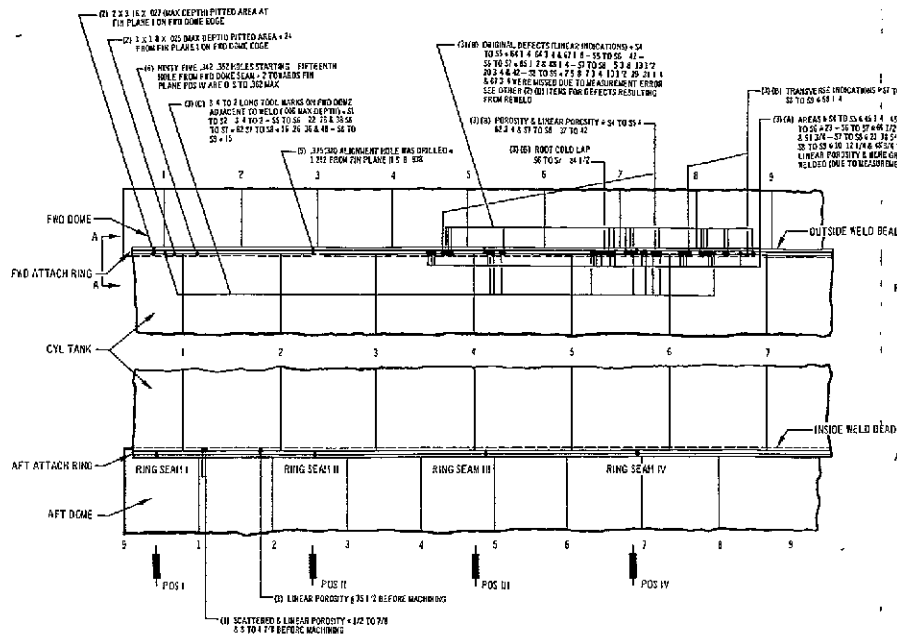
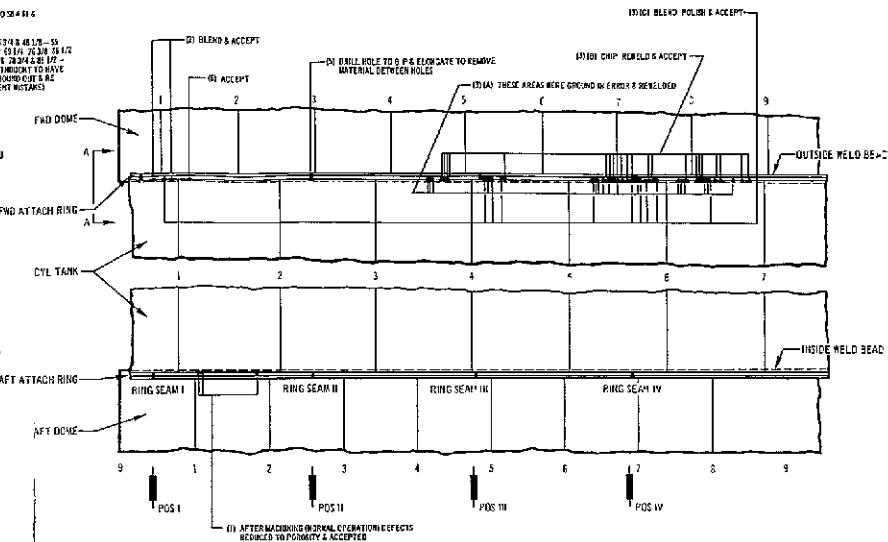
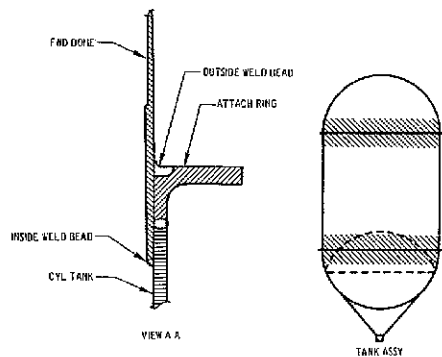
ITEM	FARR NUMBER	INITIATION DATE	DEFECTS	REWORKS REQUIRED	WELDING REWORK	REWELOS
(1)	A221451	10/23/02	3	6	N/A	0
(2)	A220490	11/14/04	2	2	N/A	0
(3)	A220491	11/14/04	47	47	AUTOMAG	2
(4)	A220490	11/14/04	1	SET AFT RING - ITEM 11		
(5)	A220491	11/14/04	1	1	N/A	0
(6)	A220490	11/14/04	11	11	N/A	0
(7)	A220491	11/14/04	11	11	N/A	0
(8)	A220492	11/14/04	11	11	N/A	0
(9)	A220492	11/14/04	11	11	N/A	0
